Manhole Inspection Summary

Manhole # S55M__009MH

Inspection ☐ Is Incomplete Rating: **5) Immediate Attention Required**

Location Address: **3600 odonnell st**

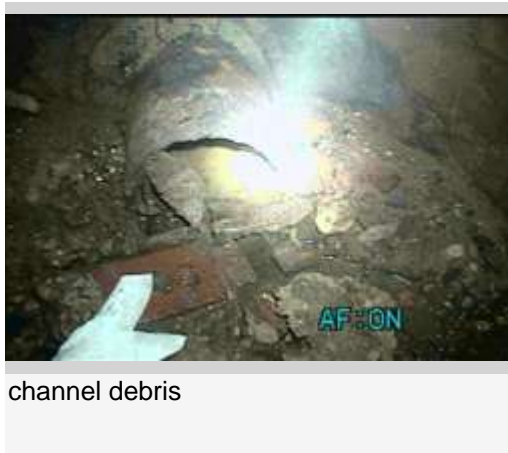
Defect 4

Condition: ☐ Sound ☐ Cracked ☐ Root Intrusion ☐ Deteriorated ☐ Leaks ☒ **Debris**

channel debris

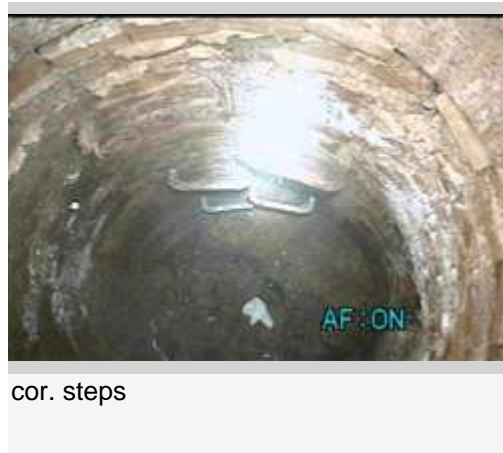
Defect 3

Count: **5** Missing: **1** ☒ **Corroded**

cor. steps

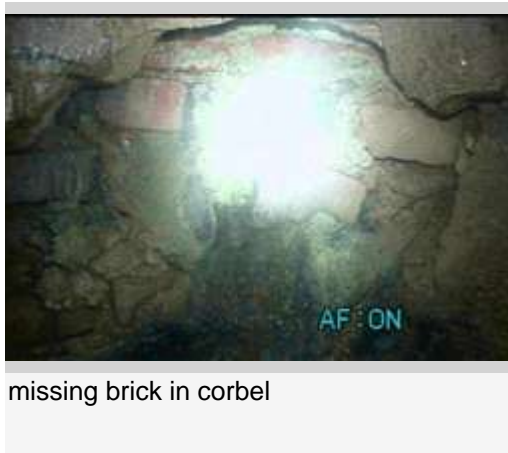
Defect 2

Condition: ☐ Sound ☒ **Cracked** ☐ Root Intrusion ☒ **Loose Brick** ☒ **Deteriorated**

missing brick in corbel

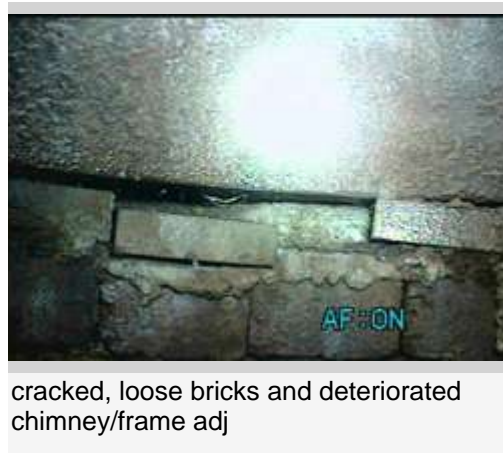
Defect 1

Condition: ☐ Sound ☒ **Cracked** ☐ Root Intrusion ☒ **Loose Brick** ☒ **Deteriorated**

cracked, loose bricks and deteriorated chimney/frame adj

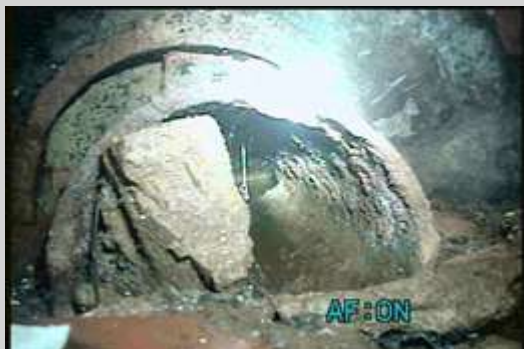
6 O'Clock Inflow

Deposits: ☐ None ☐ Mud ☐ Sludge ☒ **Debris** ☐ Grease

Silt Depth: 4 (in.) Deposits Extent: **Medium**

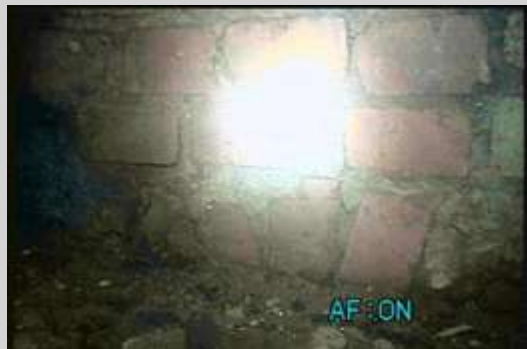
9 O'Clock Inflow

filled up with debris
